# Bank Pin Erosion Monitoring Project Perkiomen Creek

Status Report: Aug 2020 – April 2021

# Bank Pin Monitoring—Upper Perkiomen Creek

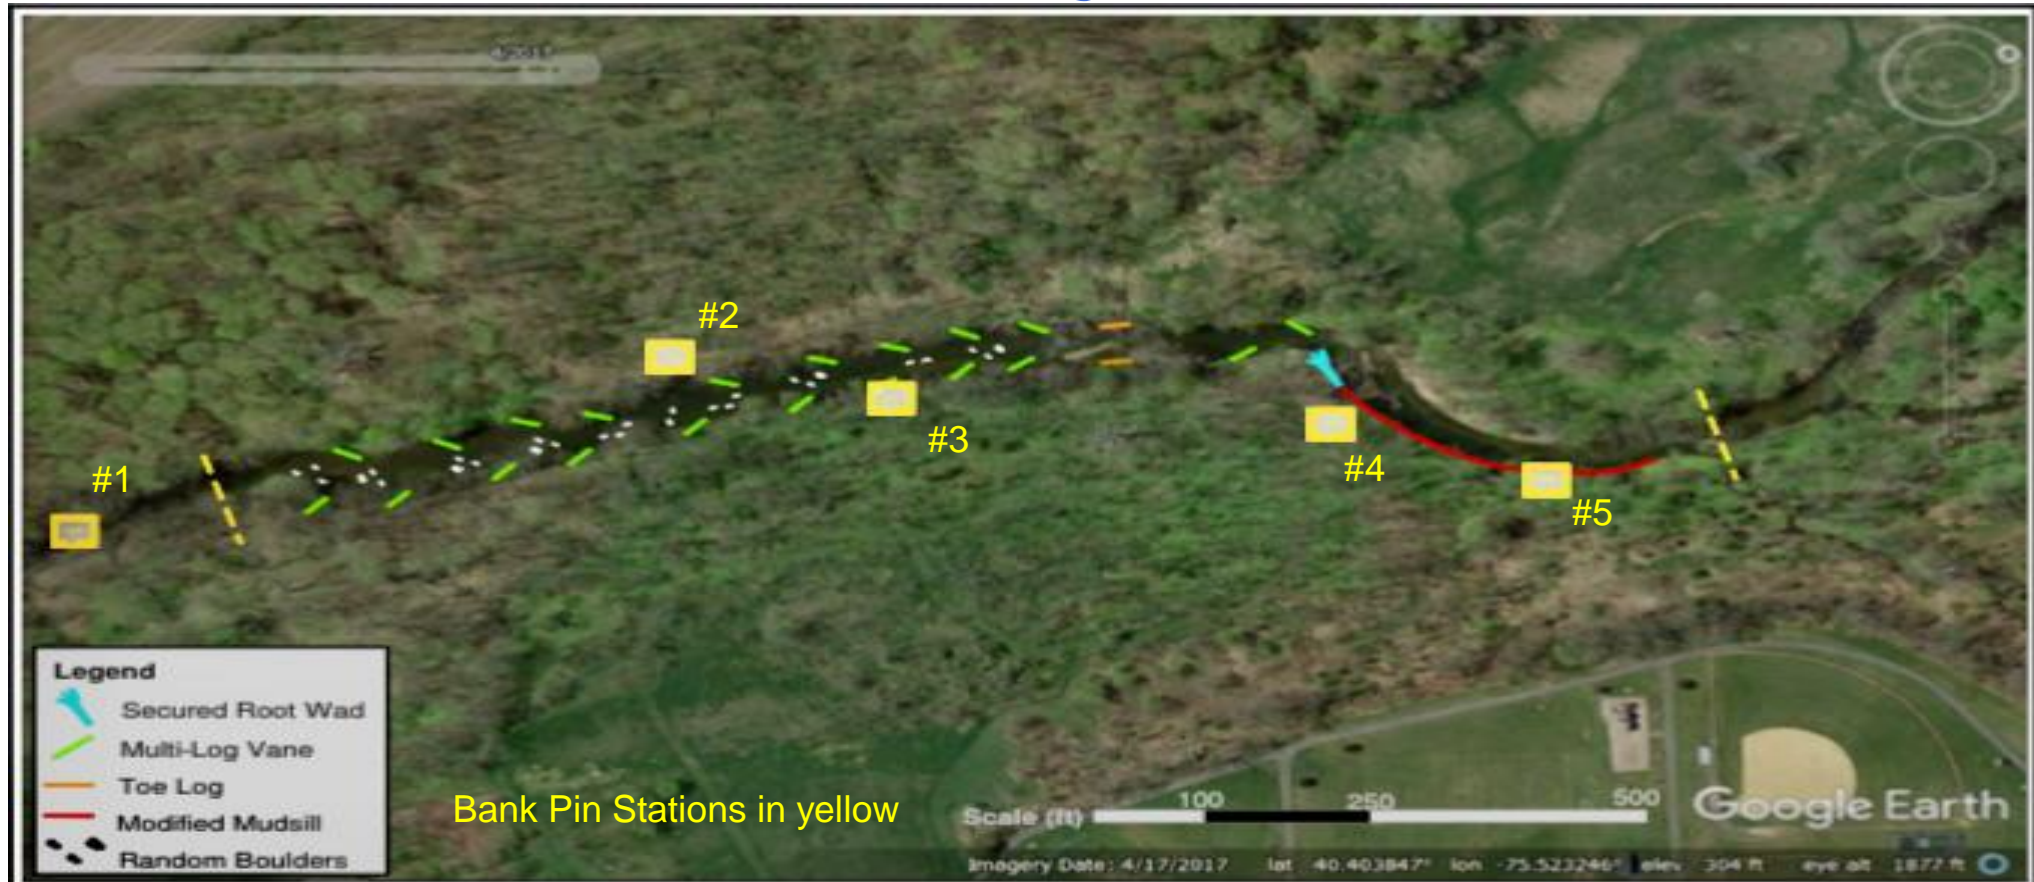
Bank Pin Stations in yellow

**Perkiomen Creek Stream Habitat Improvement Project**  
Conceptual Design Plan

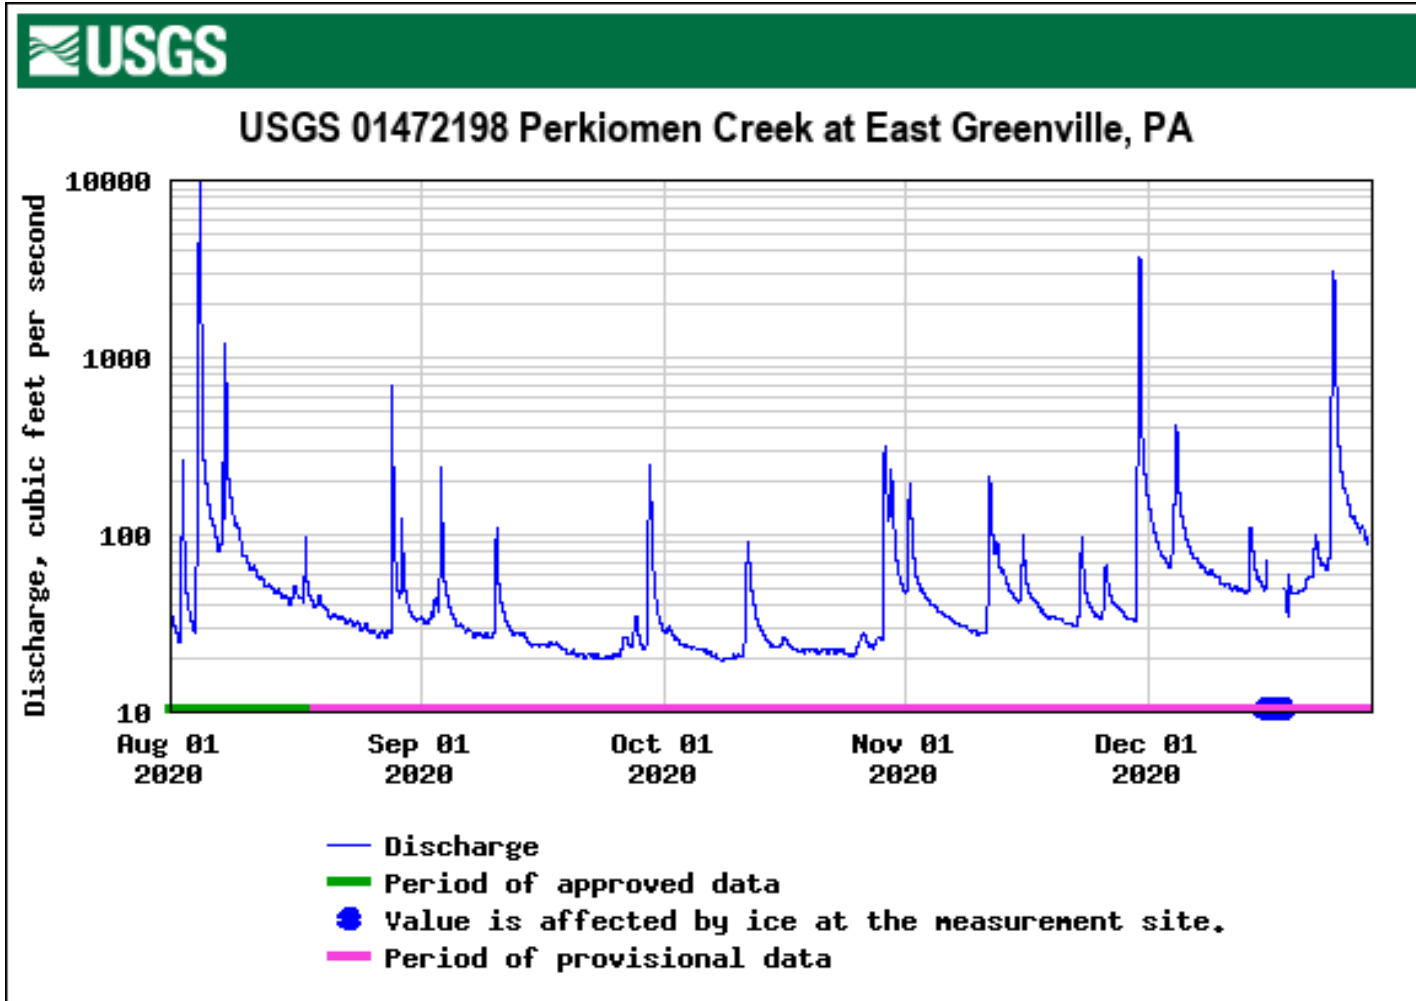
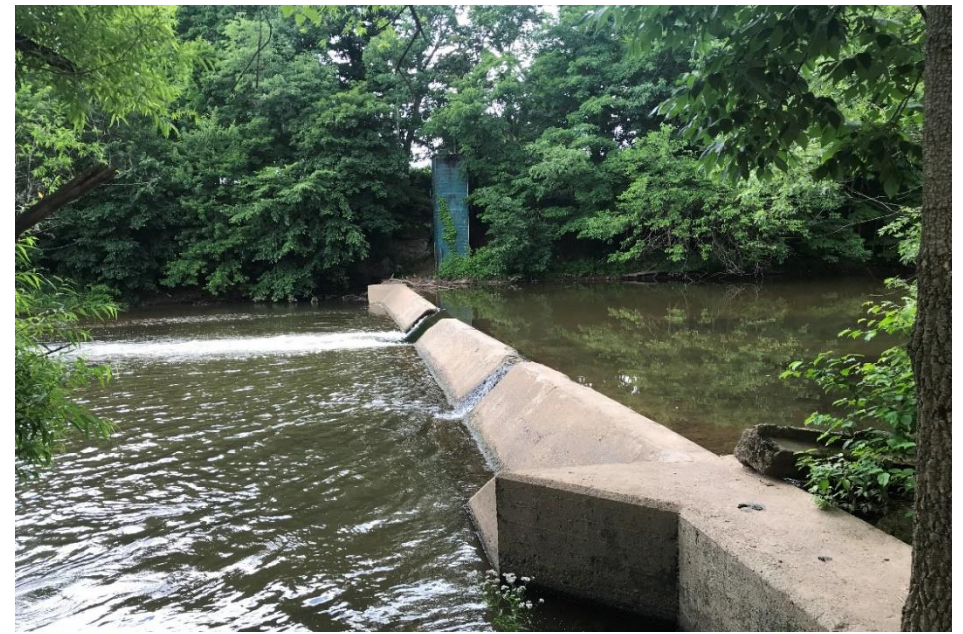
# USGS Stream Flow Data

- Real Time flow data
- Flow (Q or discharge)
- Stage (height of water)
- Alerts on high flows
- Safety/Access

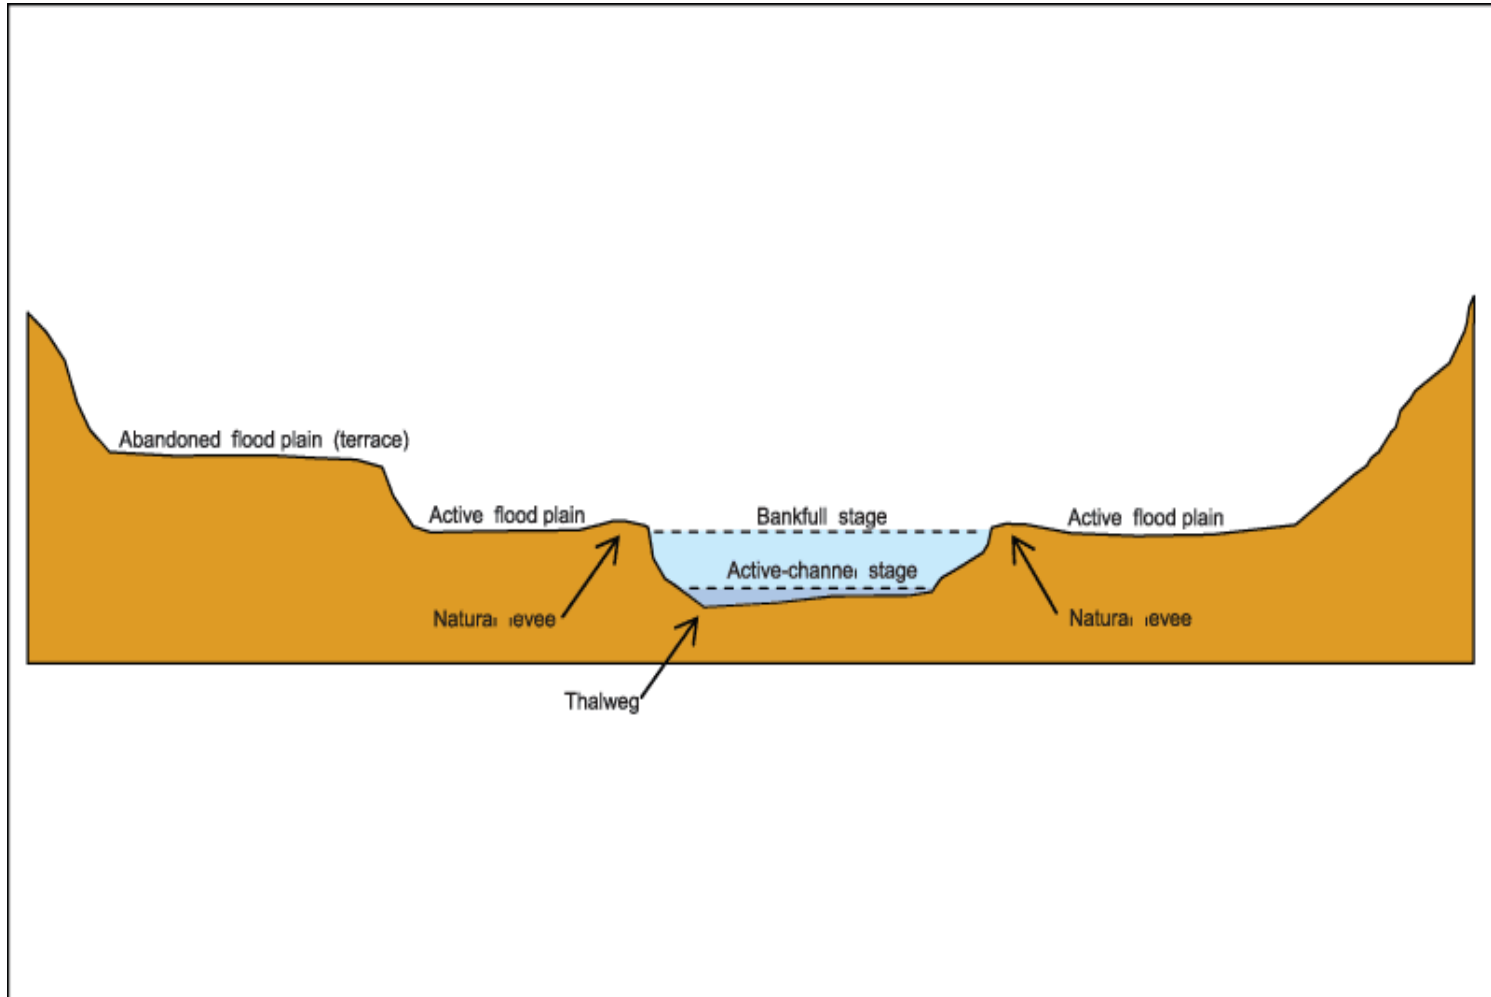
- Streamflow (discharge= $Q$ ) is related to channel characteristics (width, depth, slope, sinuosity)
- At bankfull flow (flow at which stream jumps its banks) streams have most impact on moving sediments and altering channel geometry.
- On average, streams attain their bankfull flow/stage at 1-2 times per year.

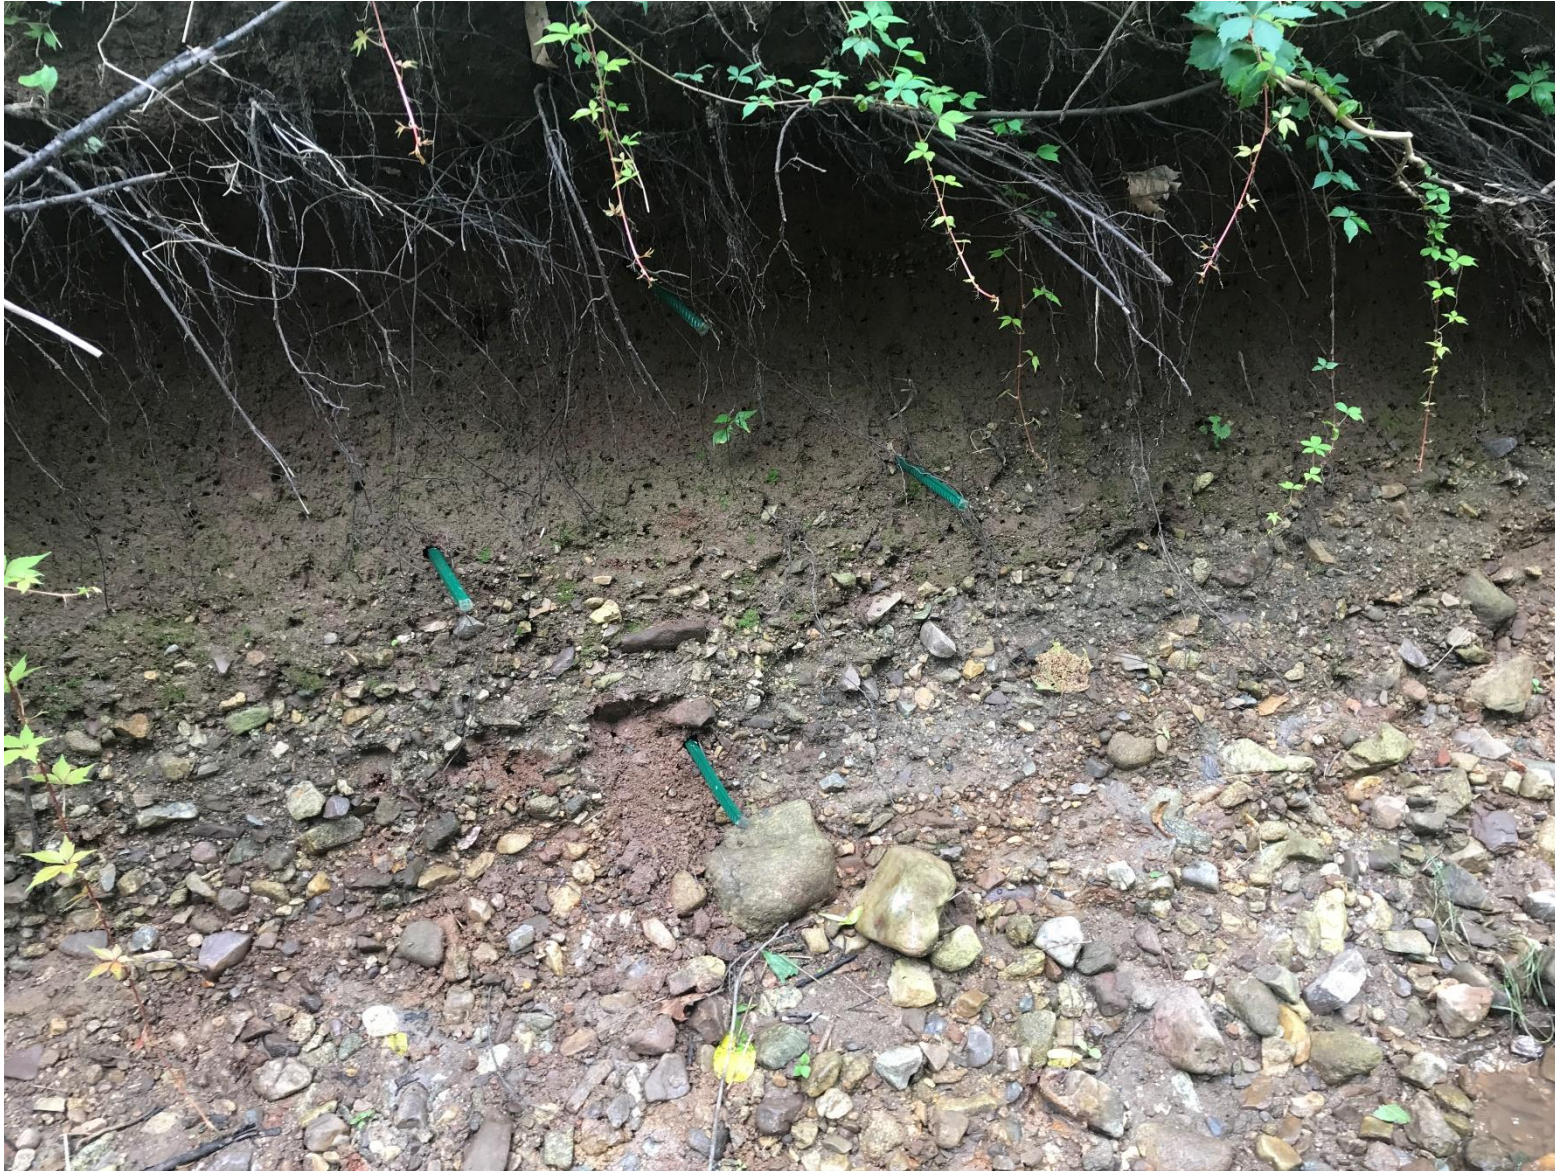
# Typical Bank Profile – Station 4

- Unconsolidated sediments
- Stratification
- Cobbles, gravels, coarse sand, silt
- Alluvial material grading to organic soil profile with vegetative root mat

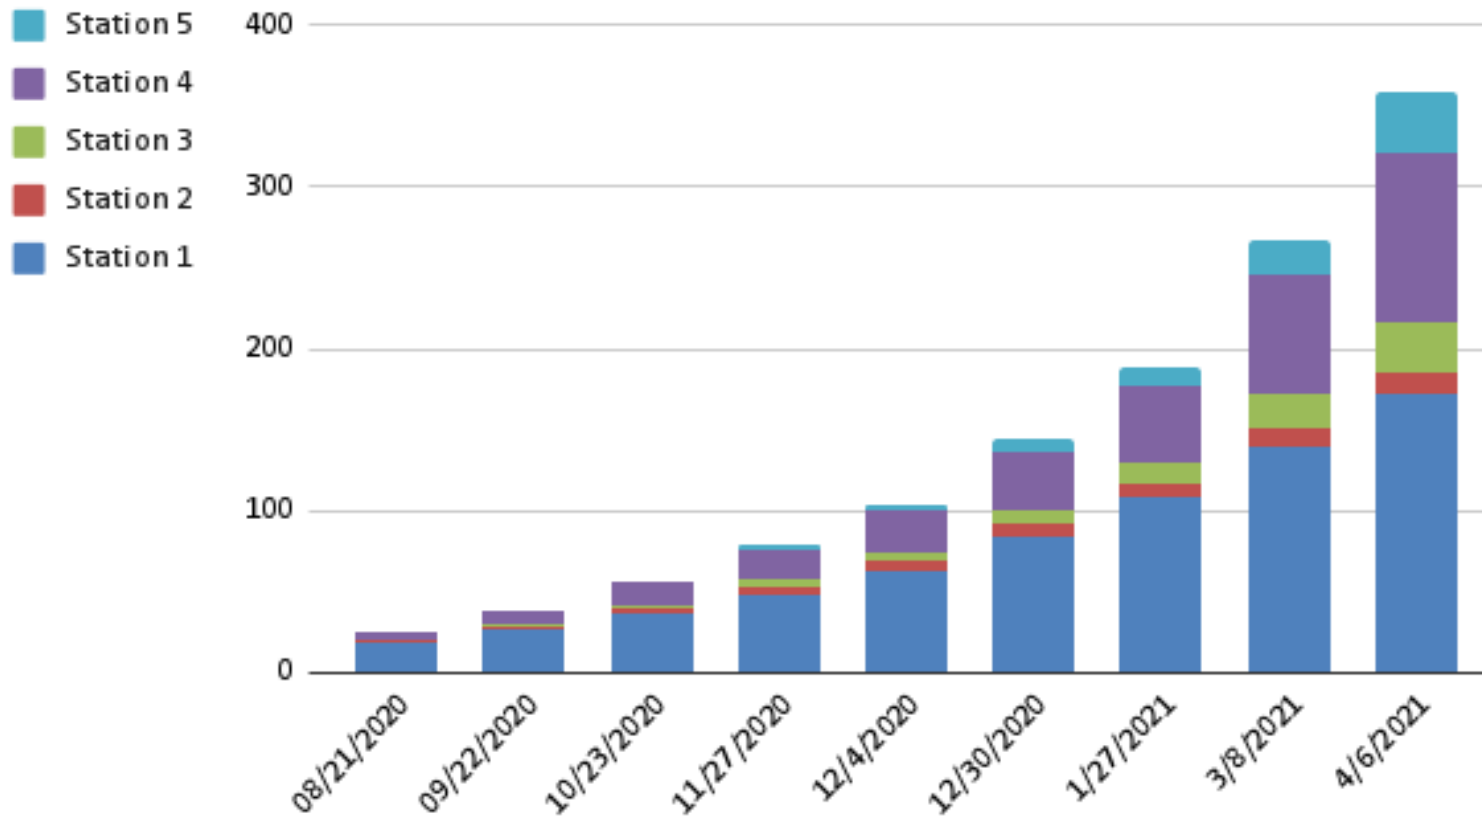
Cumulative Erosion Across All Sites (in cm)

Total cumulative erosion across all stations was approximately 11.5 ft

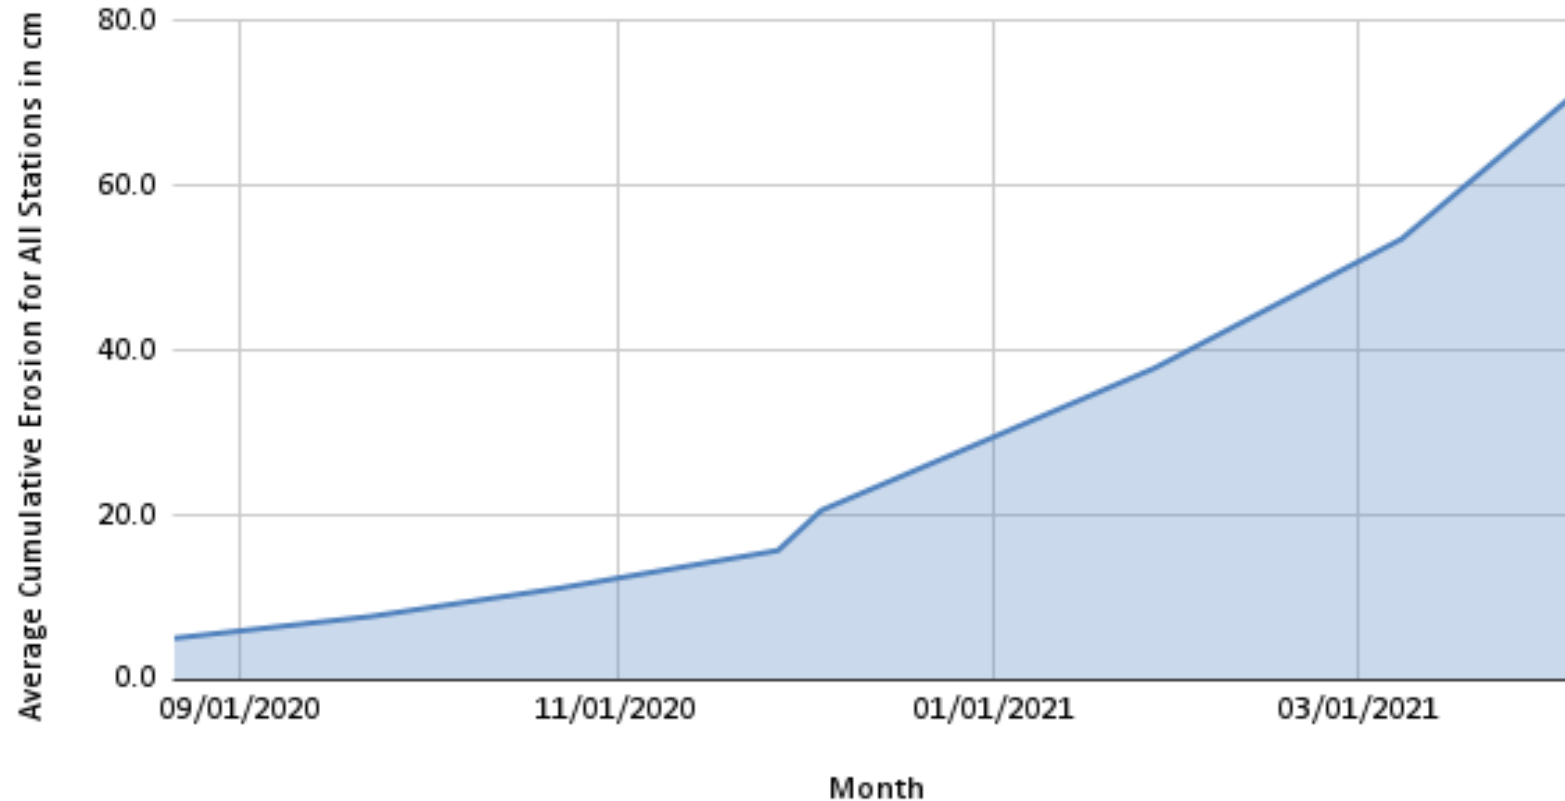
Average Cumulative Erosion by Station vs. Month

The average cumulative erosion rate across all stations was about 2.3 ft. over 9 months

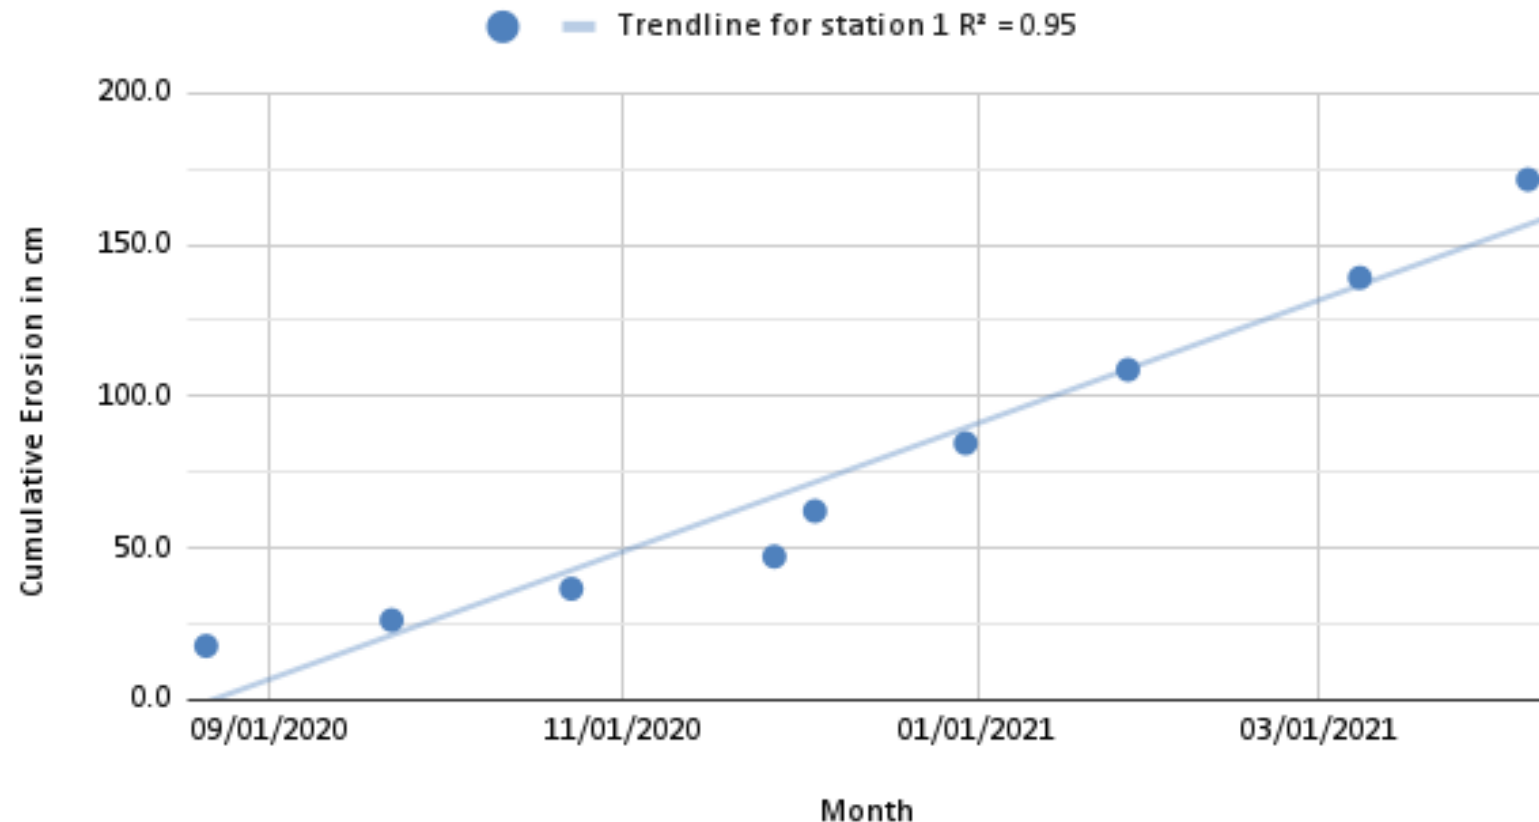
Station 1 by Cumulative Erosion by Date

Station #1 experienced the highest rate of cumulative erosion: over 5.5 feet

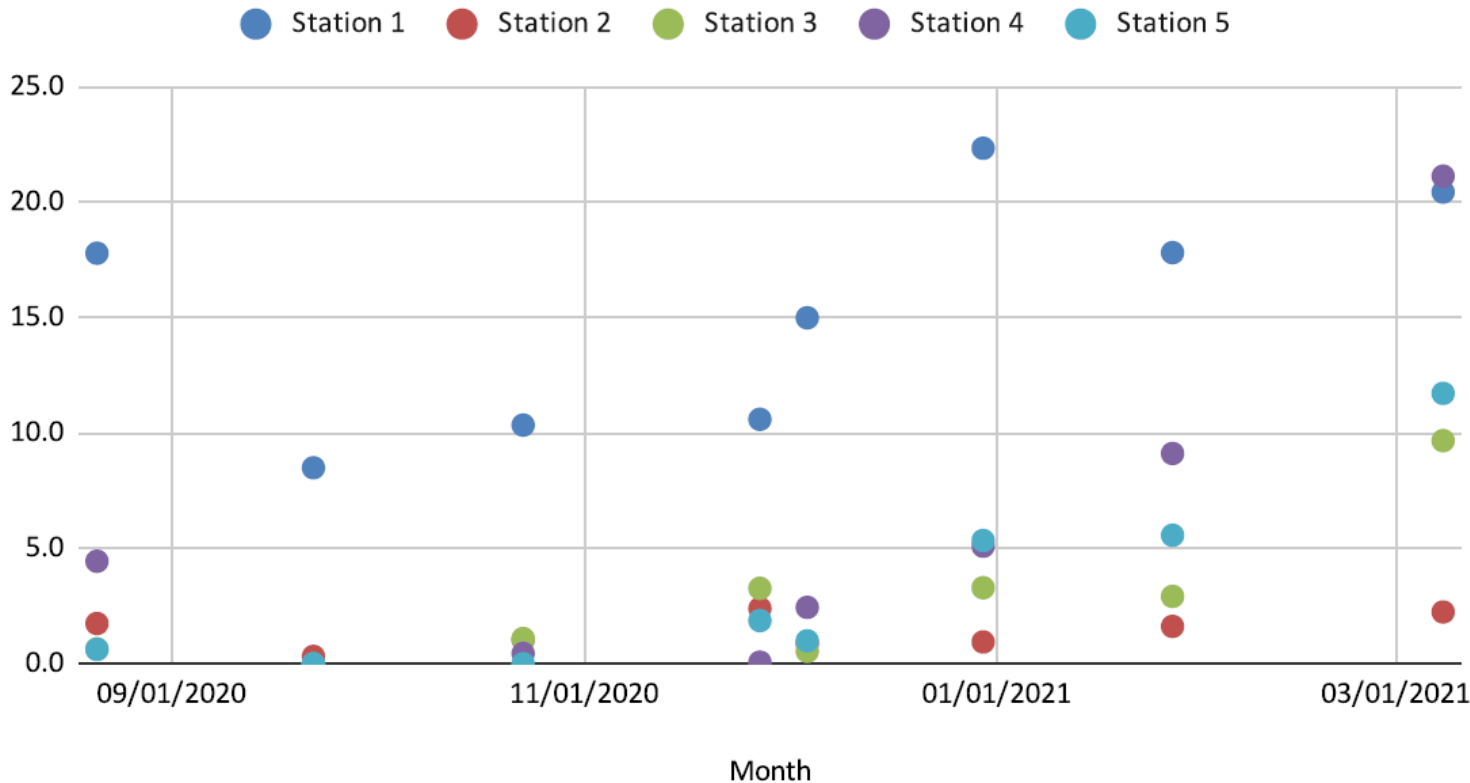
Monthly Erosion by Station

- **Station #1** consistently highest erosion – highly unconsolidated bank materials and opposite bank is bedrock (confines flow)
- Flows in Feb produced highest erosion rates at all stations; Sept/Oct the lowest
- **Station #4** consistently next to highest; then **Station #5**

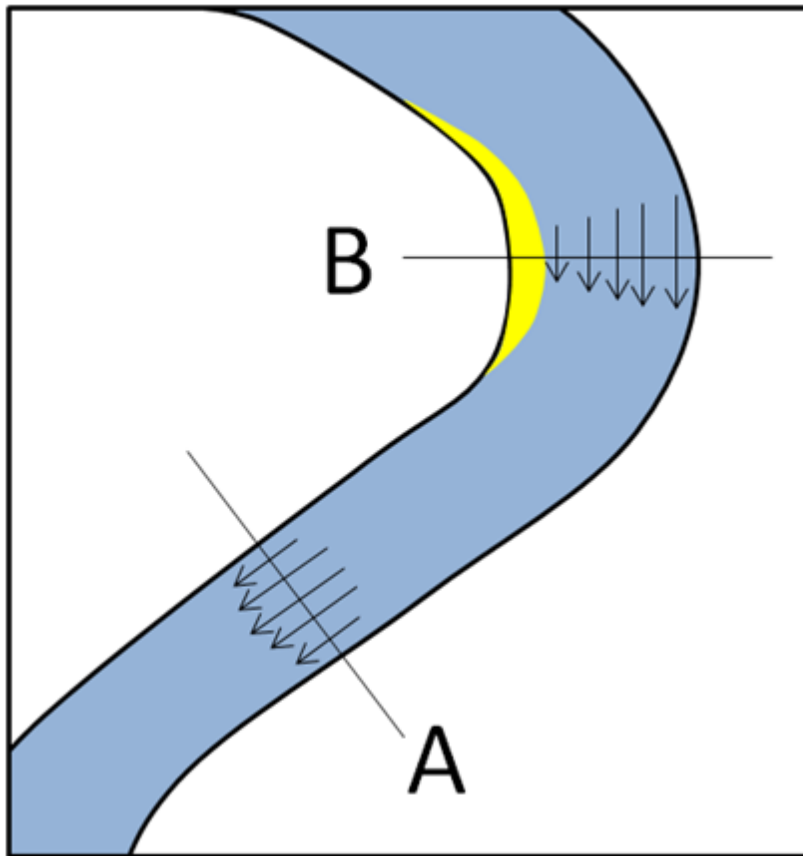
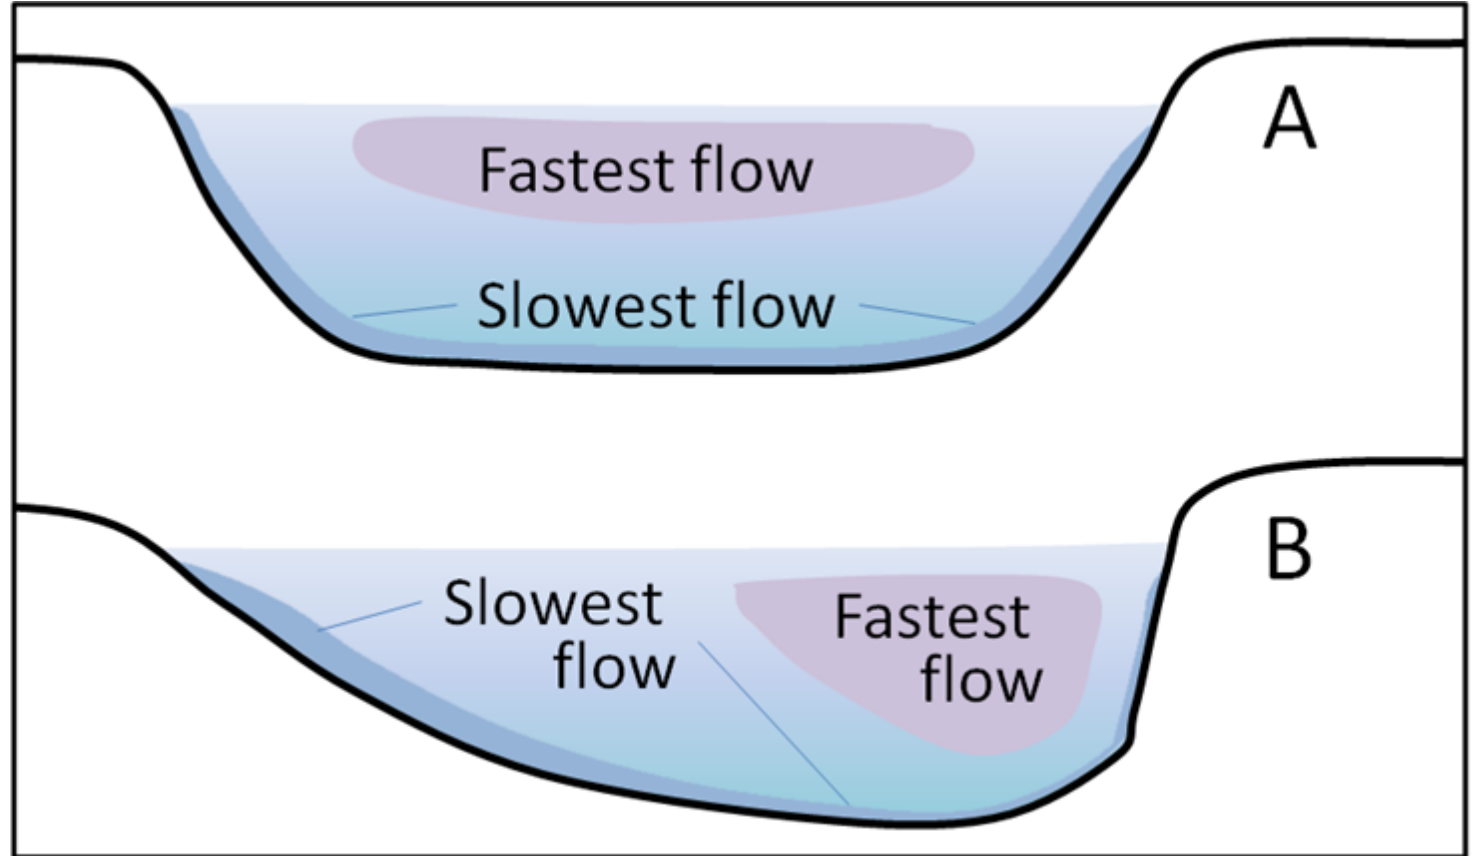
# Outside (concave) bank stations showed high rates of erosion – Stations #4 and #5
